Forensic Engineering, PLLC  
3948 Third Street South  
Jacksonville Beach, FL 32250  
904.473.5186

September 5, 2017

Re: Loraine Pullin Lynn  
Death Investigation  
D.O.L.: August 1, 2017  
FE File No.: 20170806A

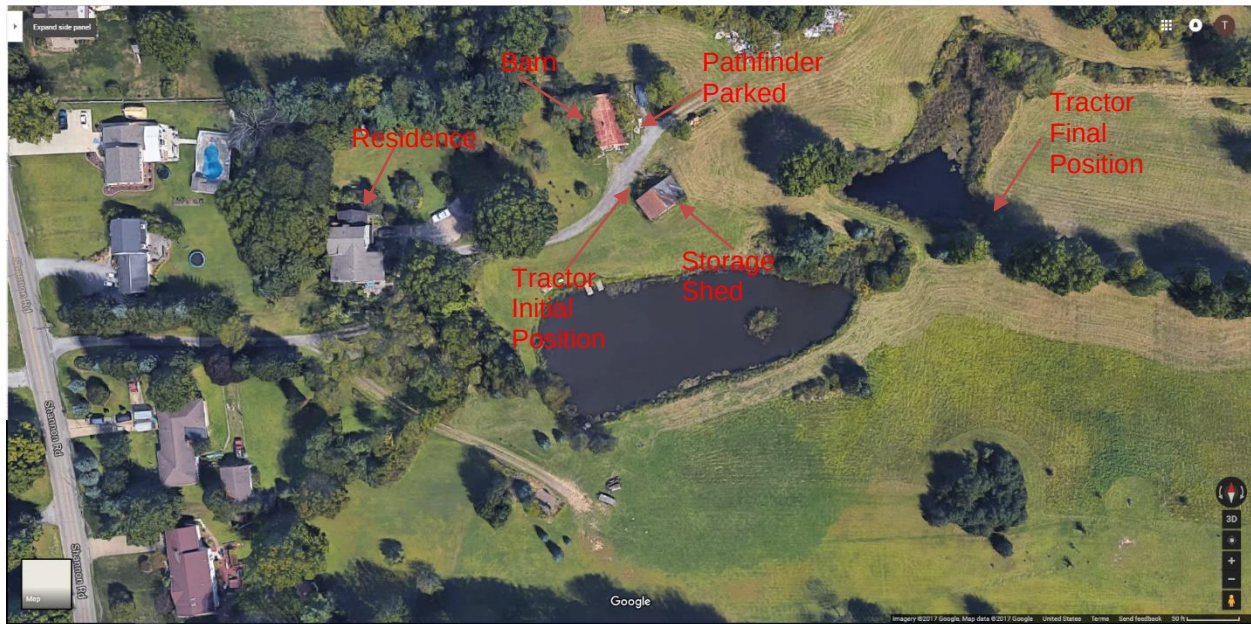
*Figure 1: Aerial View of Subject Property*

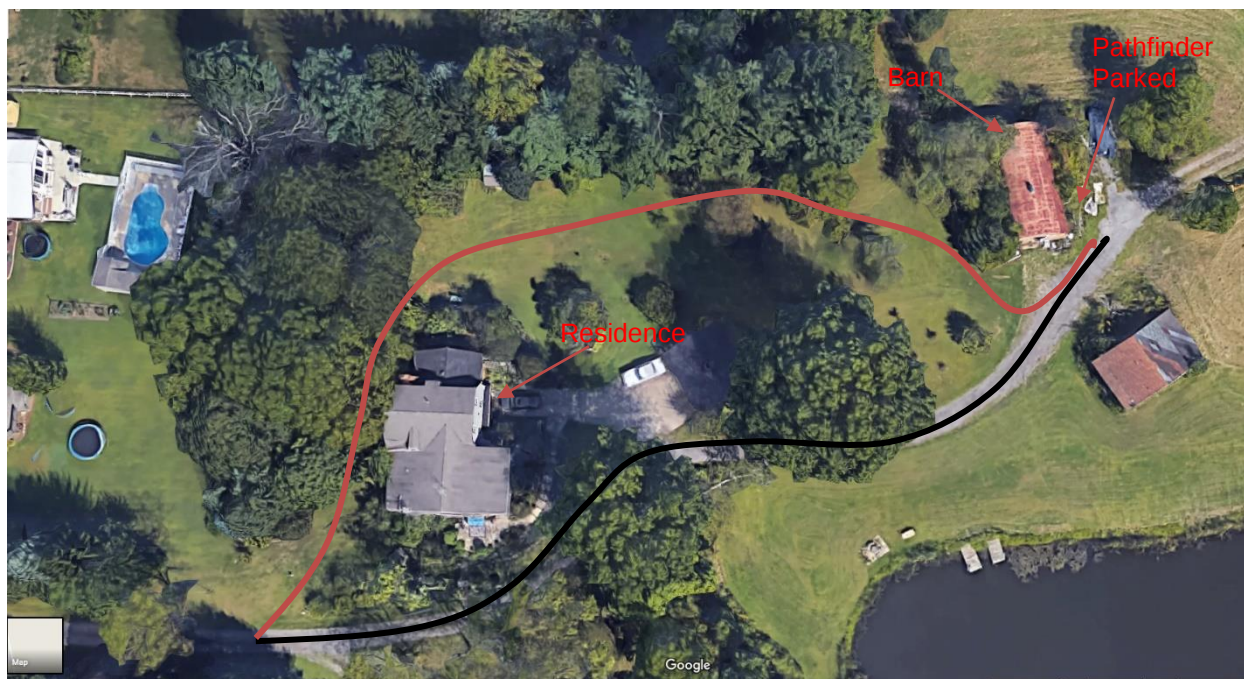
Since the video footage was available for review, Ms. Diane Pullin was tasked with watching all four feeds to determine the timeline for when Lori arrived and left her mother's property. After three viewings of the August 1<sup>st</sup> footage it was determined that Lori had arrived earlier in the day but left after finding her mother not home. The footage shows Lori arriving at the house, carrying her purse, at 11:02am on August 1, 2017 then driving away at 11:36am. The driveway was used for both arrival and departure. Her car is then seen again at 12:14pm driving through the front and side lawn of the house rather than using the driveway. It is unknown why Lori's vehicle would take this circuitous path to get to the barn rather than the straighter and safer path of the driveway. See Figure 8. The black path shown in Figure 2 is a gravel and compacted drivable pathway that is built for the purpose of vehicles obtaining access to the residence and the outbuildings. The red path shown in Figure 2 is the circuitous path taken by the Lori's vehicle at 12:14pm. This path is not improved and has rocks and trees to avoid in order to prevent damage to the vehicle. The vehicle is not observed leaving during the rest of the day. It should be noted that using the red path shown in Figure 2 has the potential to avoid the video surveillance cameras whereas the black path does not.

Figure 2: Aerial view outlining the driveway path and the surveillance path of the Pathfinder

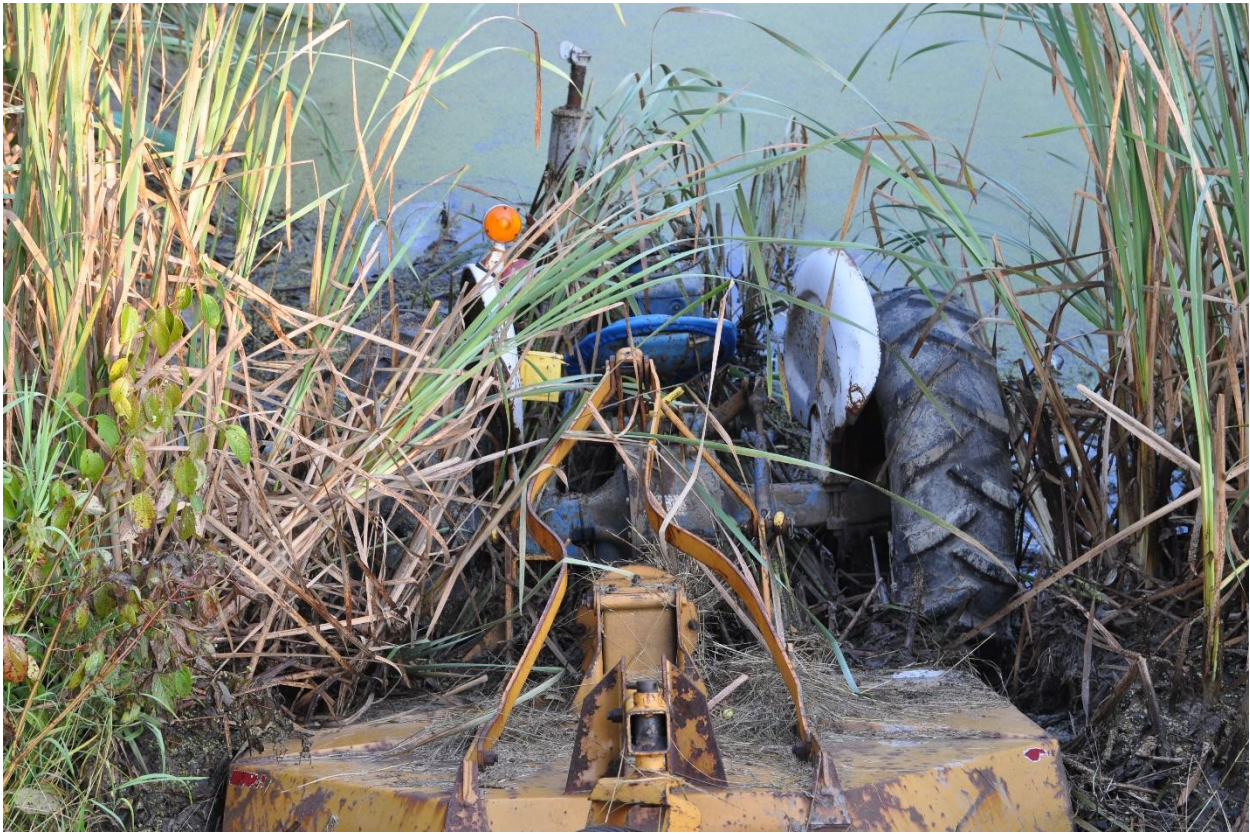
Upon arrival at the subject property on Tuesday August 8<sup>th</sup>, 2017 a meeting was conducted with the property owner, Mrs. Wanda Pullin (Deceased's Mother), Diane Pullin (Deceased's Sister) and Mark Schoonover (Deceased's Fiancé). During this meeting, the path of the tractor was walked and ended at the north-east corner of a small pond. A farm tractor was observed partially submerged in the water. The pond was being pumped down in order to lower the water level enough to gain access to the entire tractor. See Figure 3.

On Wednesday morning August 9<sup>th</sup>, 2017, the pump had removed enough water from the pond in order to gain access to the front portion of the tractor. The front tires were embedded in mud and weeds. The gear shifter was determined to be in the neutral position and the speed selector was set to high. The key switch was in the run position. The throttle was set to half speed and the PTO was engaged. The tractor is a 1978 Ford 2000 manufactured in 1978 with a 6-speed transmission and a 950 rpm PTO. Attached to the tractor and PTO was a rotary cutter, manufactured by Woods Equipment. It was a Dixie model MD160 with dual blades and cuts a 5-foot-wide path. See Figure 6.

*Figure 3: Partially submerged tractor*

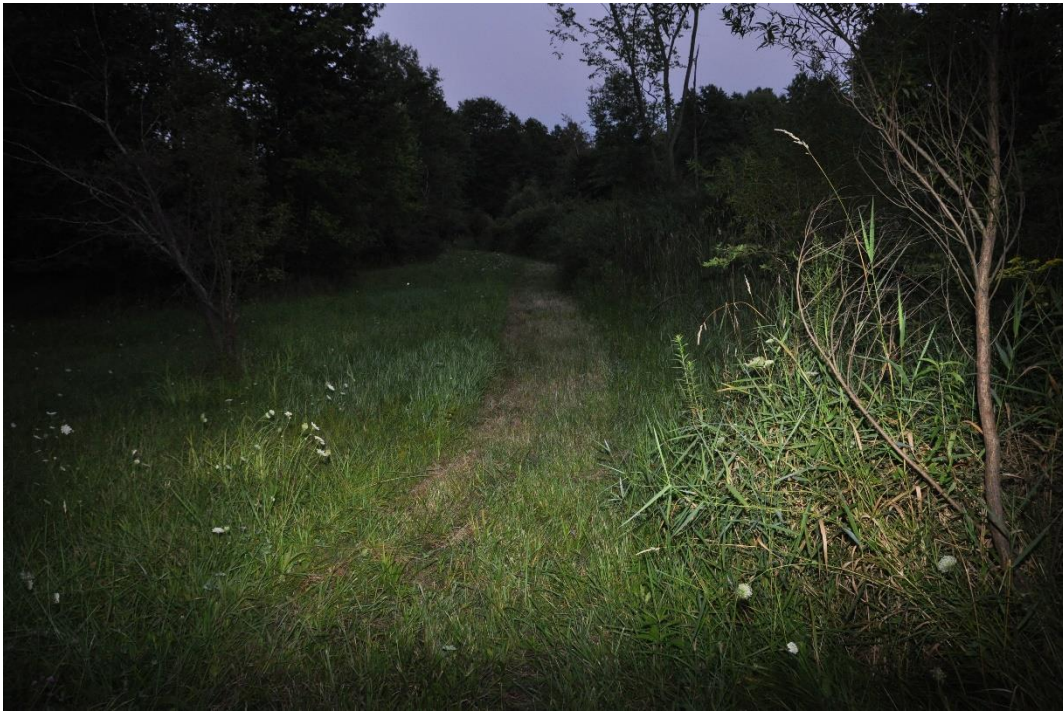
*Figure 4: Trail of cut grass leading from original tractor location*

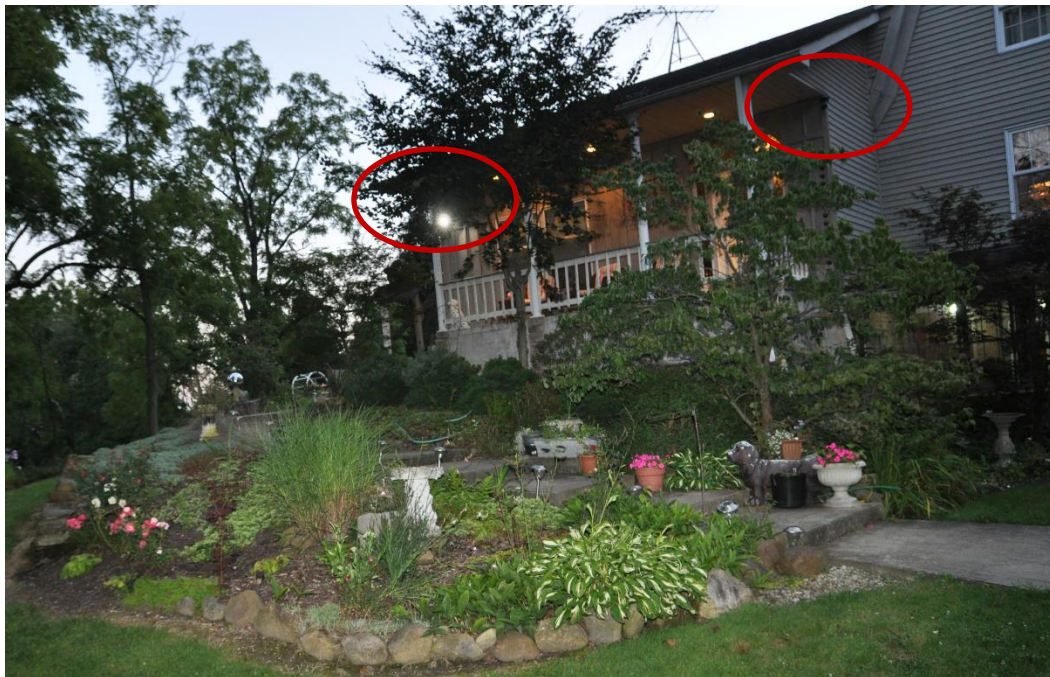
This meeting also revealed the presence of four security cameras and a DVR that recorded video. The cameras were installed under the eaves near the front entrance of the residence with two facing a northerly direction and two facing in a southerly direction. See Figure 5. It was determined that the DVR did contain footage of August 1 and that data was secured by Diane Pullin for future analysis.

*Figure 5: Front view of residence – Video Camera locations circled*

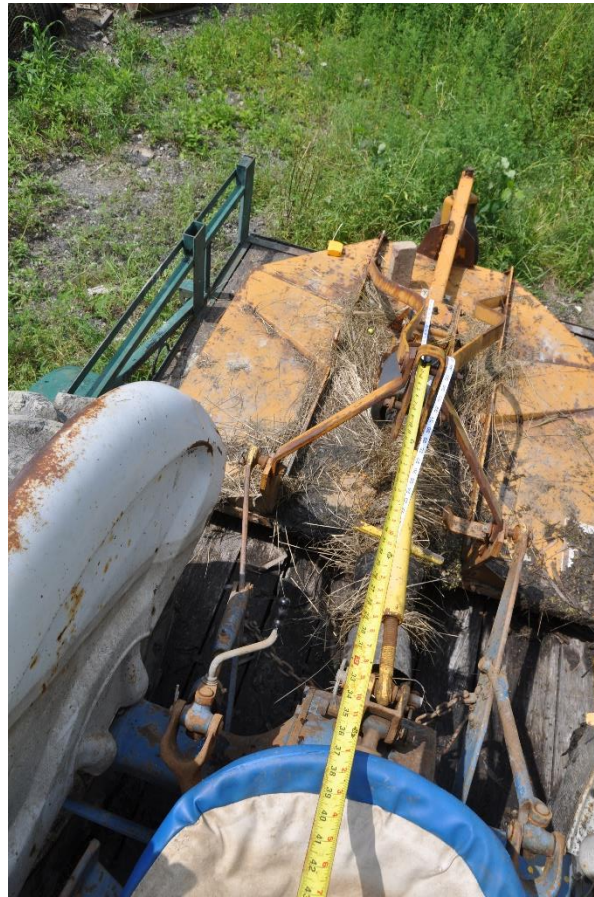
*Figure 6: Woods Dixie Cutter attachment viewed from operator's seat*

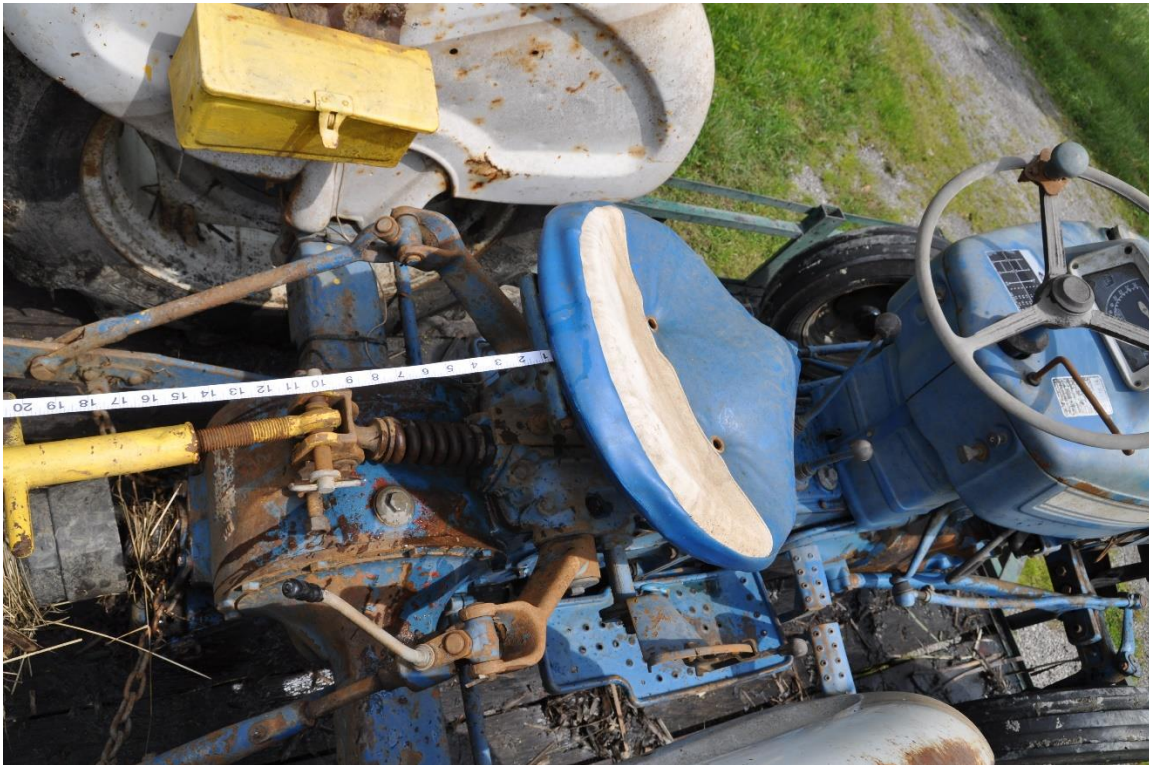
*Figure 9: Pan-style tractor seat and steering wheel*
